Additional 2mm headset spacer on 24.0" models.

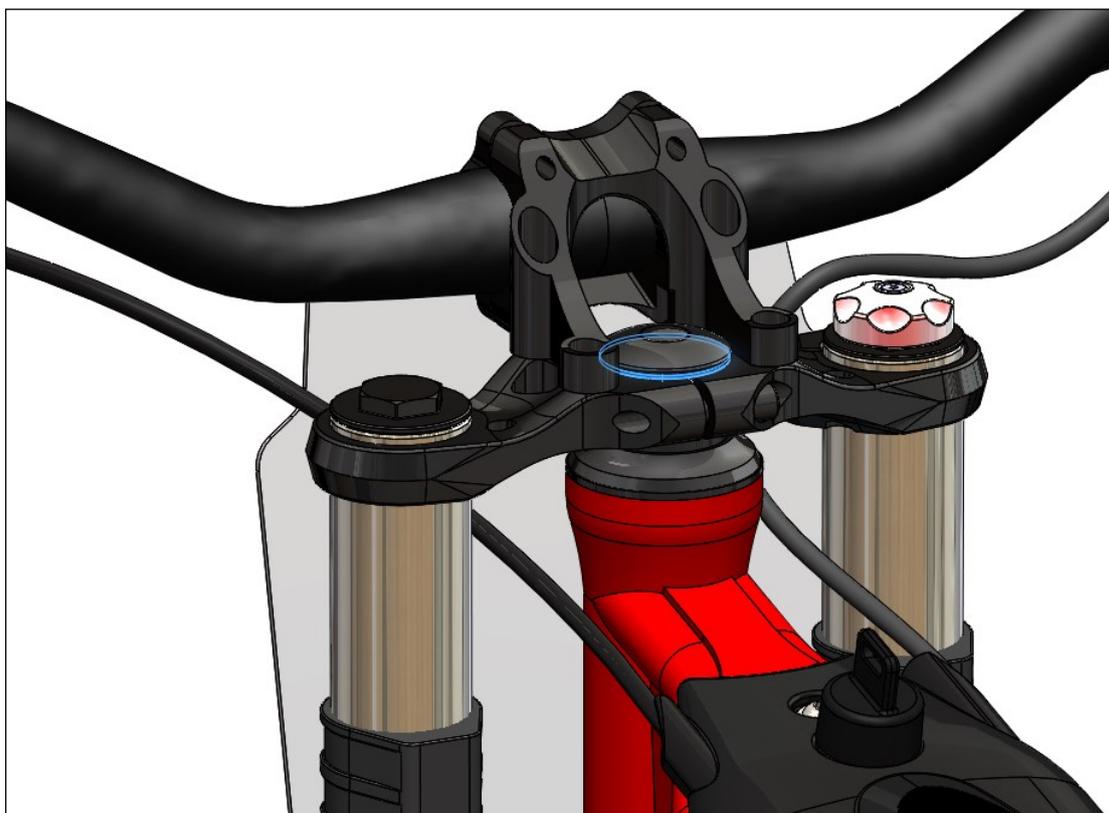
It has come to our attention that a small number of 24.0" models produced prior to 2018, may suffer from a tolerance issue which prevents the user from tightening the headset sufficiently. The cause of the issue has been identified as the headset top cap resting on the very top edge of the fork steerer tube, rather than the headset spacer as required.

The main symptom of this issue is a very slight 'knocking' noise & vibration when rocking the bike forwards & backwards with the front brake held on. If this knock is present and adjustment doesn't solve the problem, it can suggest the main headset bearing is not correctly tensioned and requires an additional spacer to be fitted.

If your bike is experiencing this issue, please contact OSET to source an additional 2mm headset spacer, which when installed beneath the headset top cap, allows the system to be tightened correctly.
